Re: October 2015 Monthly Progress Report  
Administrative Settlement Agreement and Order on Consent for Removal Action  
U.S. EPA Region 10 Docket No. CERCLA 10-2009-0255  
Gasco Sediments Site within the Portland Harbor Superfund Site

Attachment A      Monthly Visual Monitoring Report for Pilot Cap Vicinity

## Visual Observations Log Form

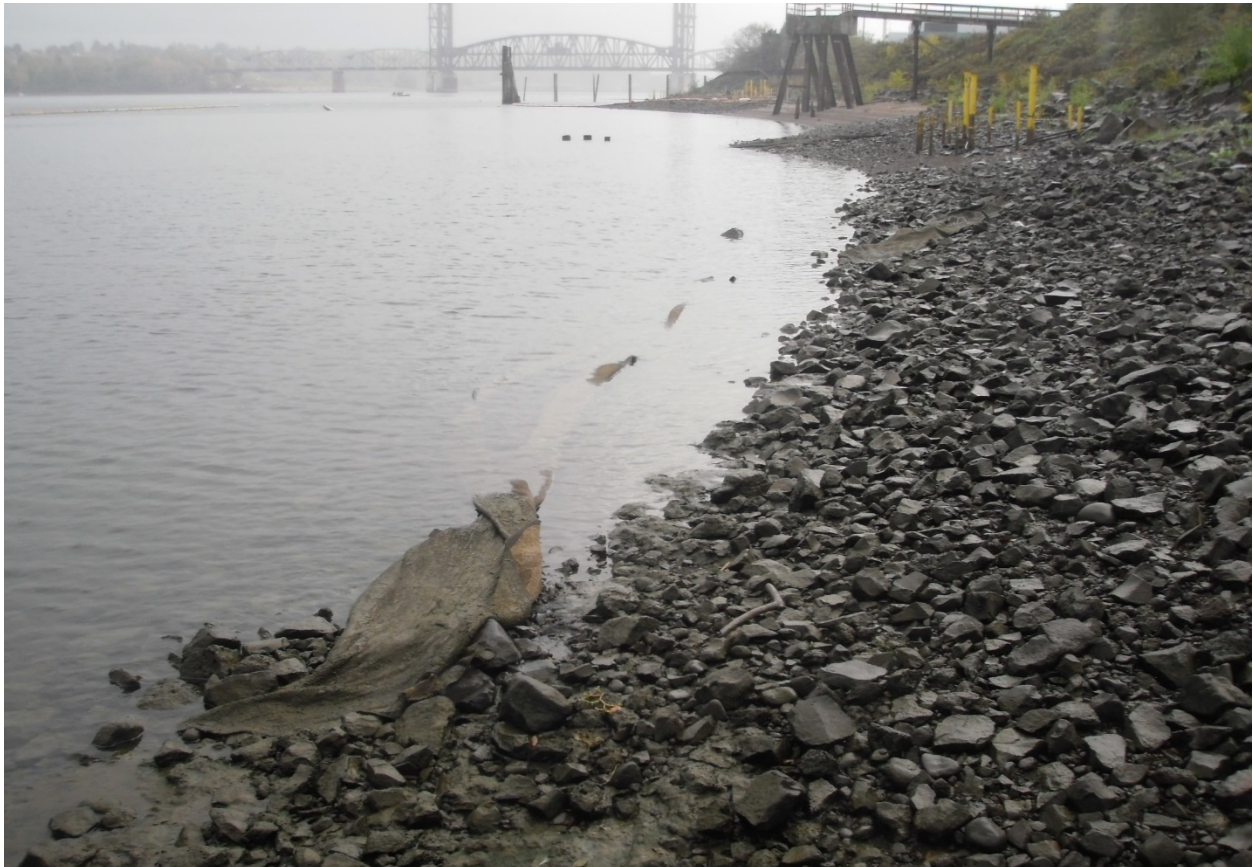
**Observations of Erosion/Deposition:** All previously noted organoclay mat material segments are visible. A segment 5 feet in length, is 7-8 feet from the water's edge near the lateral mid-point of the cap area. A 10-foot section is shoreward of the water's edge located perpendicular to the shoreline at the upriver boundary of the cap. A section of organoclay mat material measuring 40 feet in length is exposed near the downriver extent of the cap at the water/shore interface with 15 feet of the upriver segment shoreward of the waterline (Photo 1).

Photo 1 — *Visible section of organo-clay mat at the downriver extent of cap area (10/19/15):*

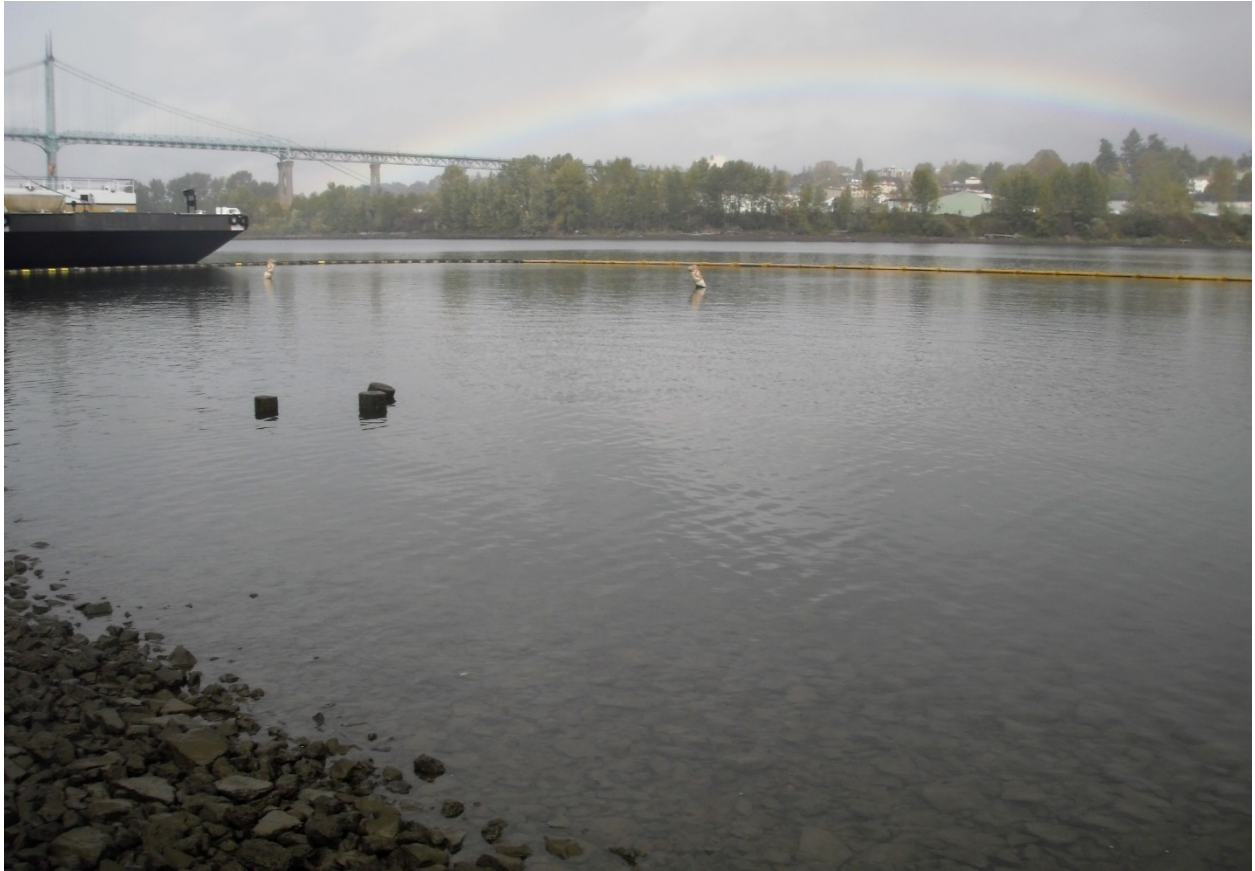
**Observations of Long-term Controls (i.e., oil booms, organo-clay mat, etc.)** During the observation, a barge was tied at the Fuel and Marine Marketing (FAMM) dock but the FAMM containment boom was placed across the cap area, from dock to riverward of the dolphin. Two buoys that identify the cap area to mariners are in place as installed. The position of the FAMM oil boom, warning buoys, and a general overview of the site shoreline is shown in Photo 2.

Photo 2 — *FAMM oil boom placement and mariner warning buoys at pilot cap area.* (10/19/15):

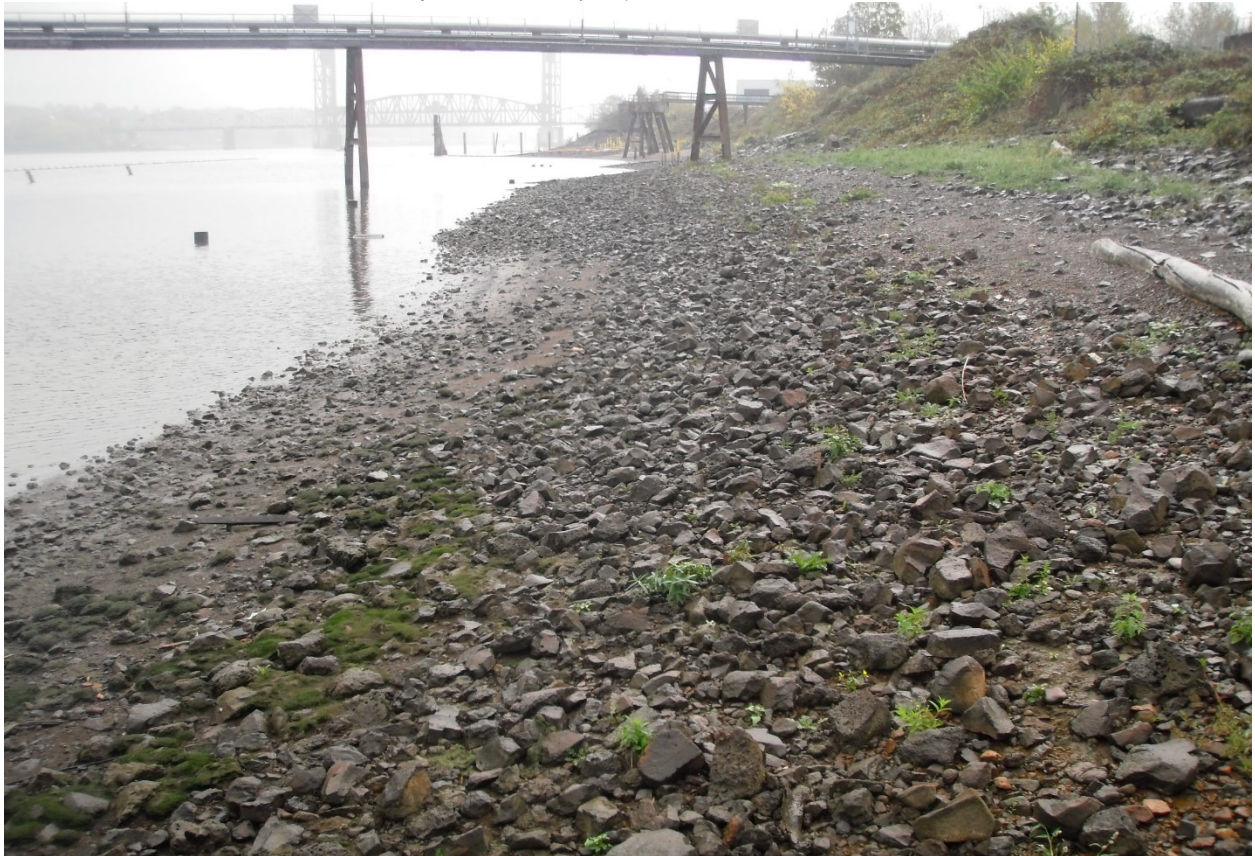
No sheen is evident in or around the cap area. Photo 3 shows the water surface and shoreline immediately downriver of the sediment cap.

Photo 3 — *Conditions immediately downriver of cap area* (10/19/15):
